AUDITOR-GENERAL
SOUTH AFRICA

Special audit of the rural household infrastructure grant and rural household infrastructure programme

JUNE 2015

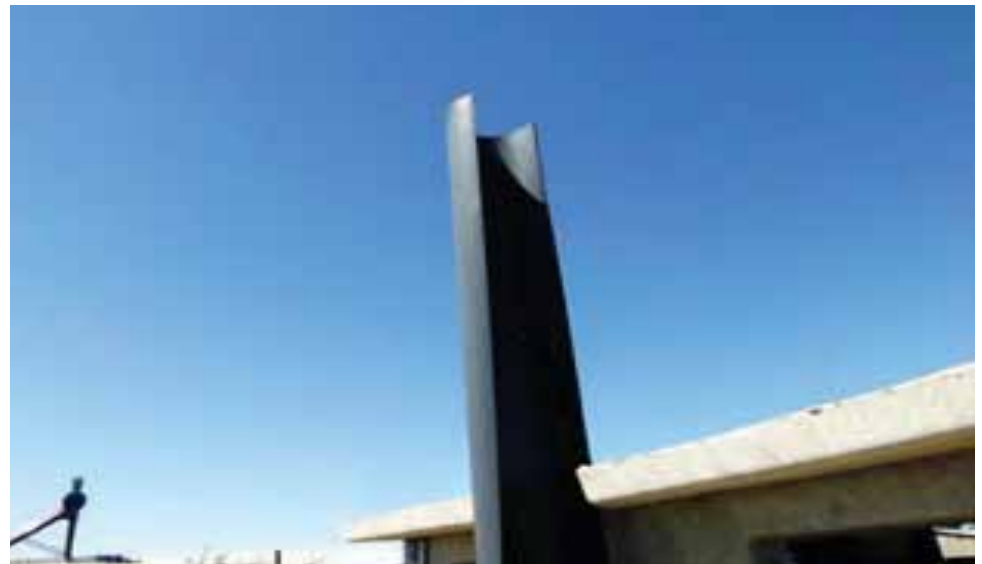
Picture 2: Vent pipe broken

- b. The broken vent pipes were caused by the contractor using poor quality material. Consequently, there were no fly screens attached to prevent foreign elements from entering the toilet pits. This resulted in the VIP toilet smelling.

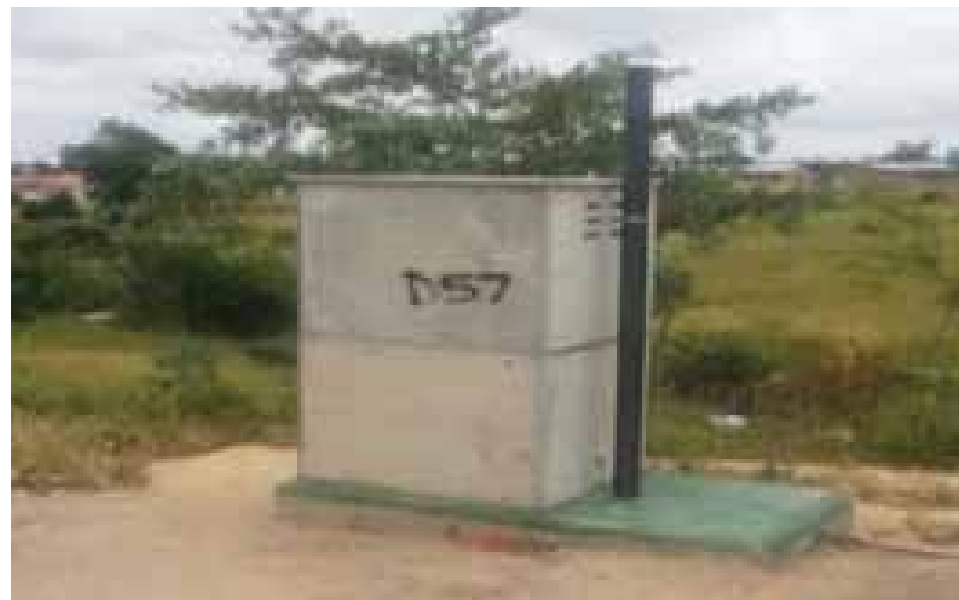
Picture 3: Uneven floor slab not compacting to soil

- g. The uneven floor slabs can be attributed to the contractor not compacting the soil correctly. This gave rise to the soil in the area settling unevenly and resulted in the brickwork to slant. In other instances, the floor slab was uneven due to the concrete slab that was damaged when it was installed. This compromised the stability of the VIP unit and should have been pointed out during the quality assurance process. This could have long-term negative effects on the quality of the structure.

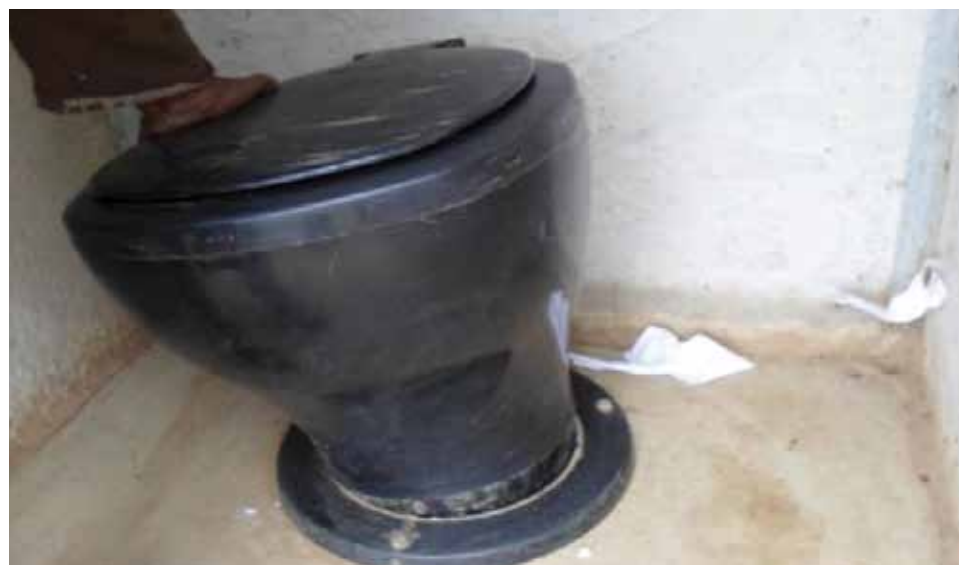
Picture 4: Toilet ring loosely fitted

- h. The toilet rings were loose because the contractor did not fit them securely. This resulted in the toilets being unstable when used. This is very dangerous as the toilet ring could detach from the floor slab and a child could fall into the pit. This was despite the toilet being inspected and the completion certificate being signed.

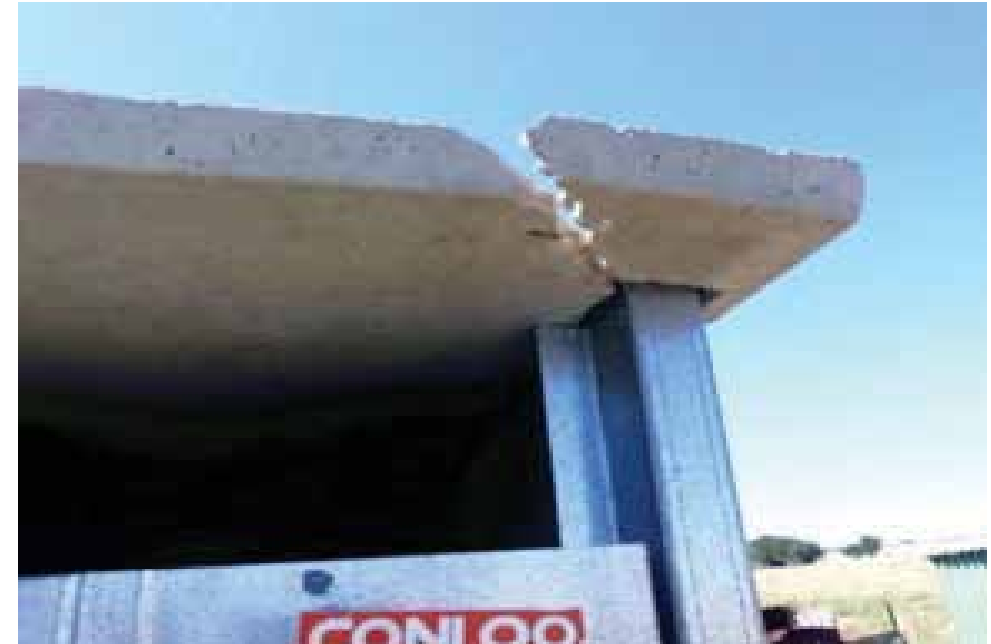
Picture 6: Roof damaged

At two of the VIP toilets visited we found that the roof of one of the structures was broken, while the roof of the other structure was cracked and sagging. This structural damage was the result of using damaged or poor quality material. The damage to the roofs of these structures also meant that they were not waterproof.

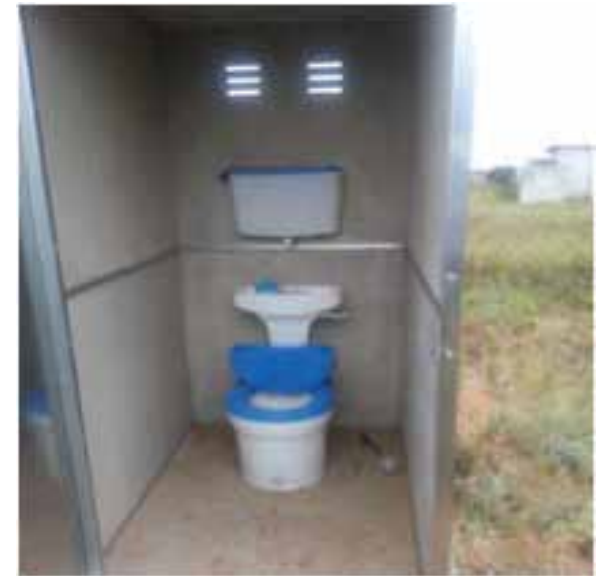
- The VIP toilet structure affords privacy of use by facing towards the house with a lockable steel door that must open inwards, to prevent the wind from breaking it.

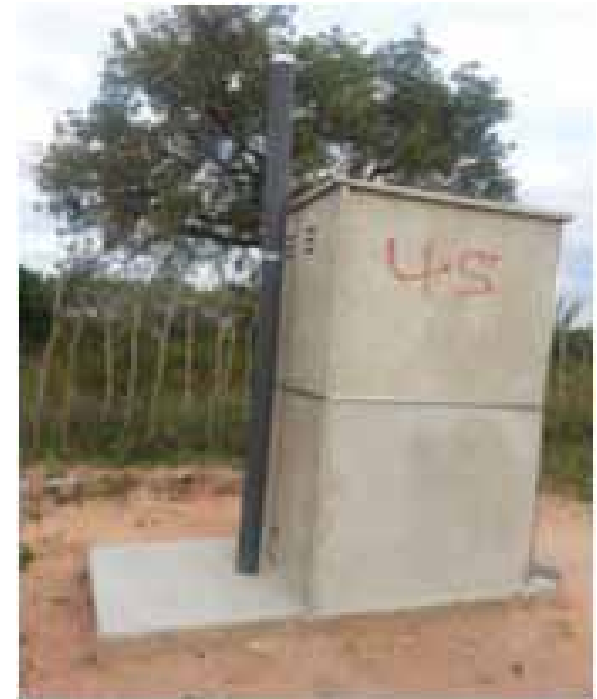
- It must not be built under or near trees, and situated in such a way that a vacuum tanker can approach the VIP toilet to within 30m of the toilet when it needs to be de-sludged.
- The pedestal must be between 350mm and 450mm high.
- The toilet seat must be properly fixed to the pedestal.
- It must have a basin for hand wash or a water holder or box, with a water bottle inside, for washing hands.
